ESL-TR-91-13
VOL II

**EXPEDIENT REPAIR OF STRUCTURAL
FACILITIES (ERSF) - VOLUME II: ERSF
SYSTEM REQUIREMENTS AND USERS
GUIDE**

JULY 1991

FINAL REPORT

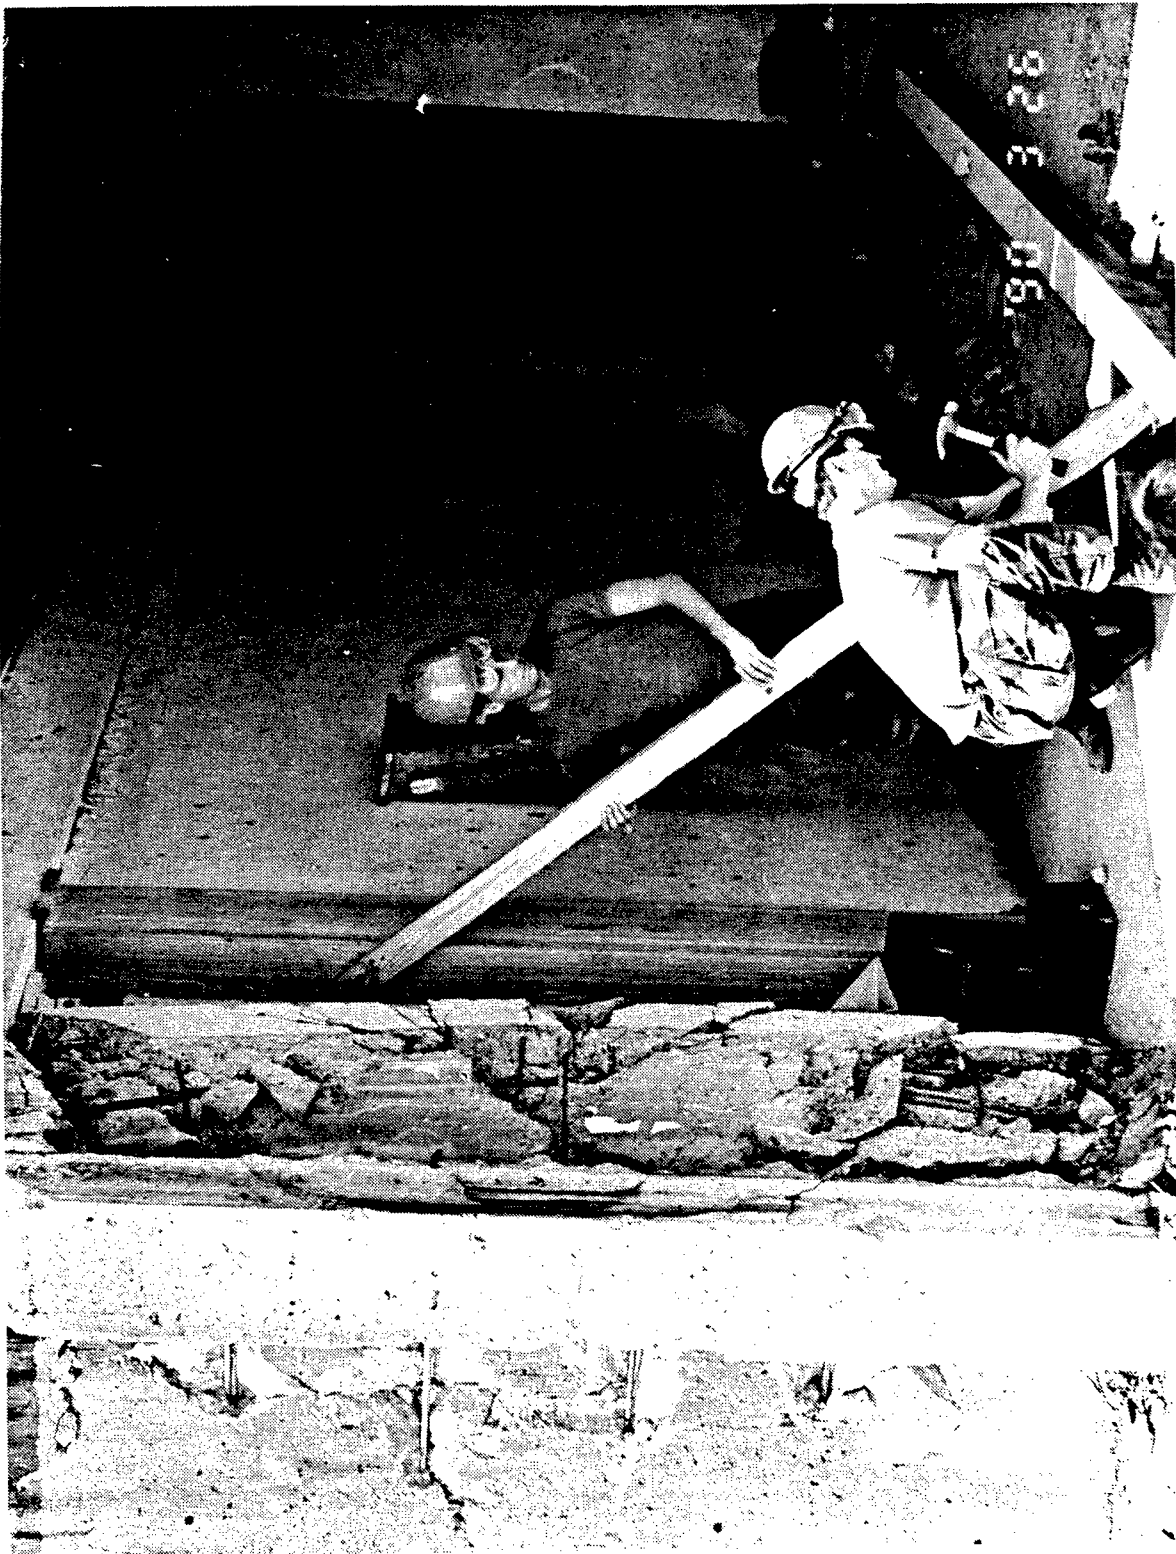
Figure 54. Attaching Lateral Bracing to Replacement Column.

Views of the column replacement process are shown in Figures 48 through 55. Debris was cleared from around the column (Figure 48). A height measurement was taken next to the damaged column, to find the required replacement column length (Figure 49). The glulam column was then trimmed to the correct length using a chainsaw (Figure 50), while a shoring jack was placed next to the damaged column and extended by hand to refusal (Figure 51). The length of the glulam column was trimmed to leave a 1/2-inch gap between the top of the column and the bottom of the roof beam. This allowed wooden wedges to be inserted between the column and the roof beam to firmly secure the column in place. The glulam column was then positioned next to the shoring jack (Figure 52), and the wedges inserted (Figure 53). Lateral bracing consisting of two-by-fours was attached to the glulam column with nails, and anchored to two-by-fours secured to the concrete floor of the structure with ramset studs (Figure 54). Finally, the shoring jack was removed (Figure 55) completing the column replacement process.

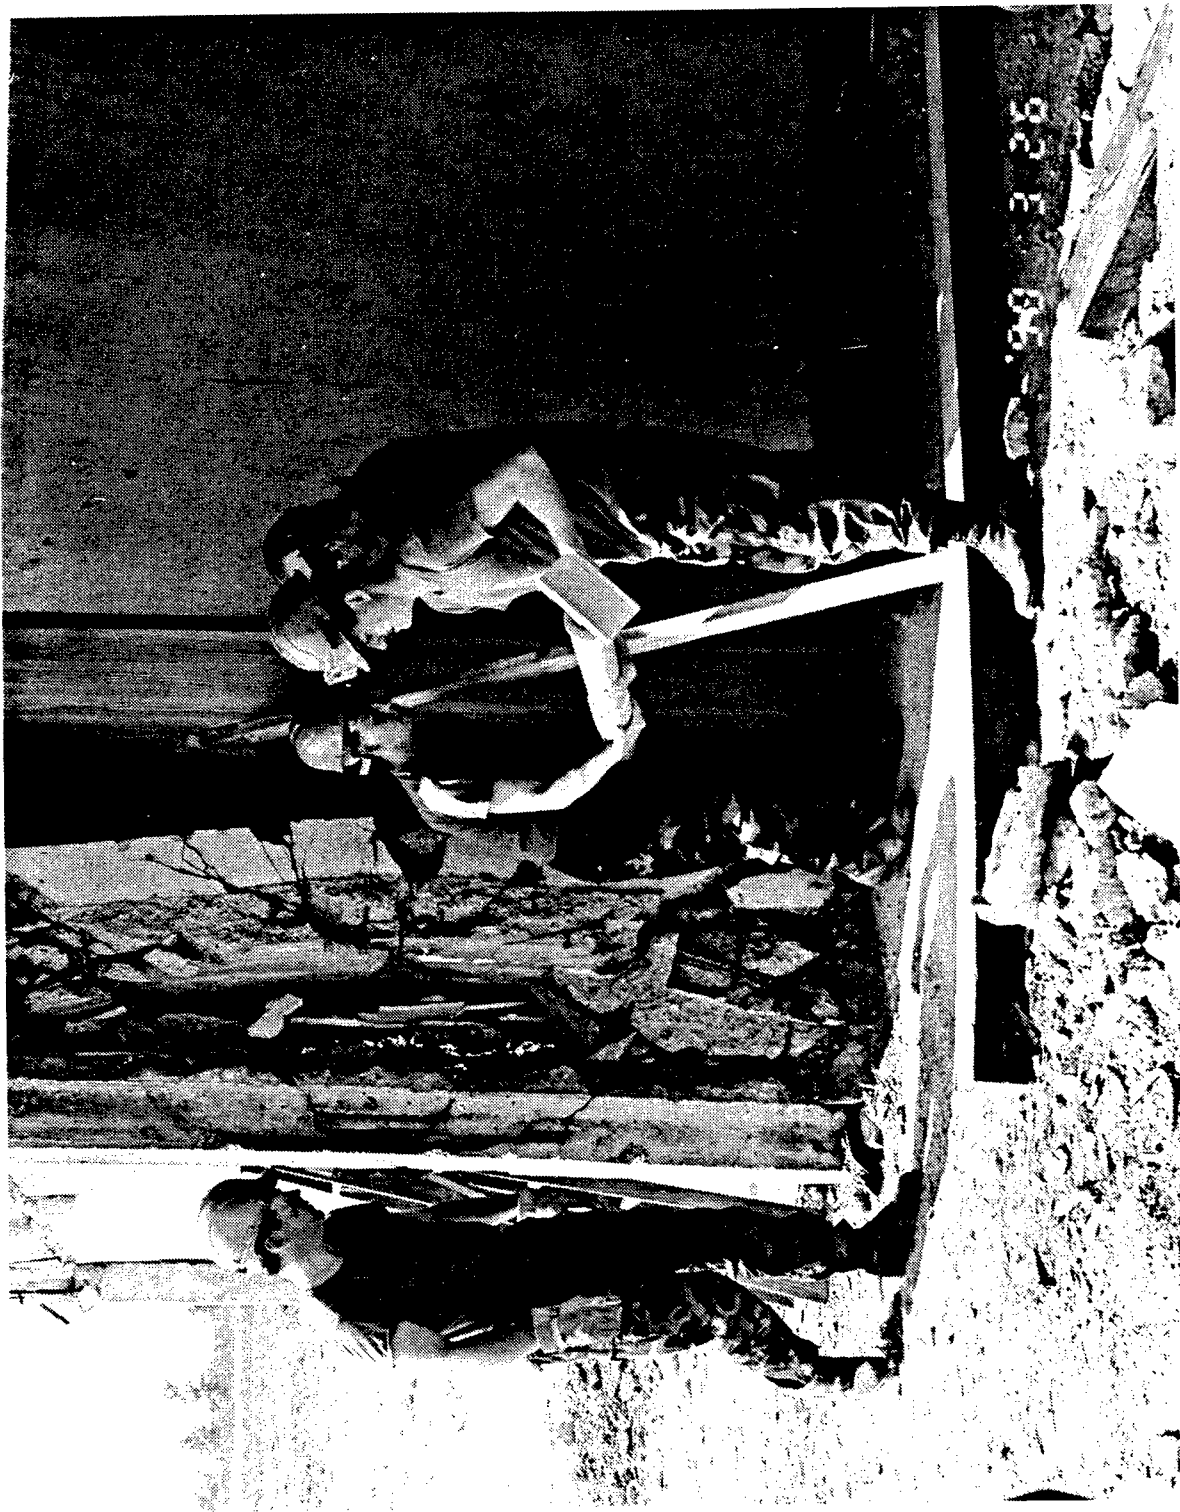
Figure 55. Removing Shoring Jack to Complete the Repair Process.

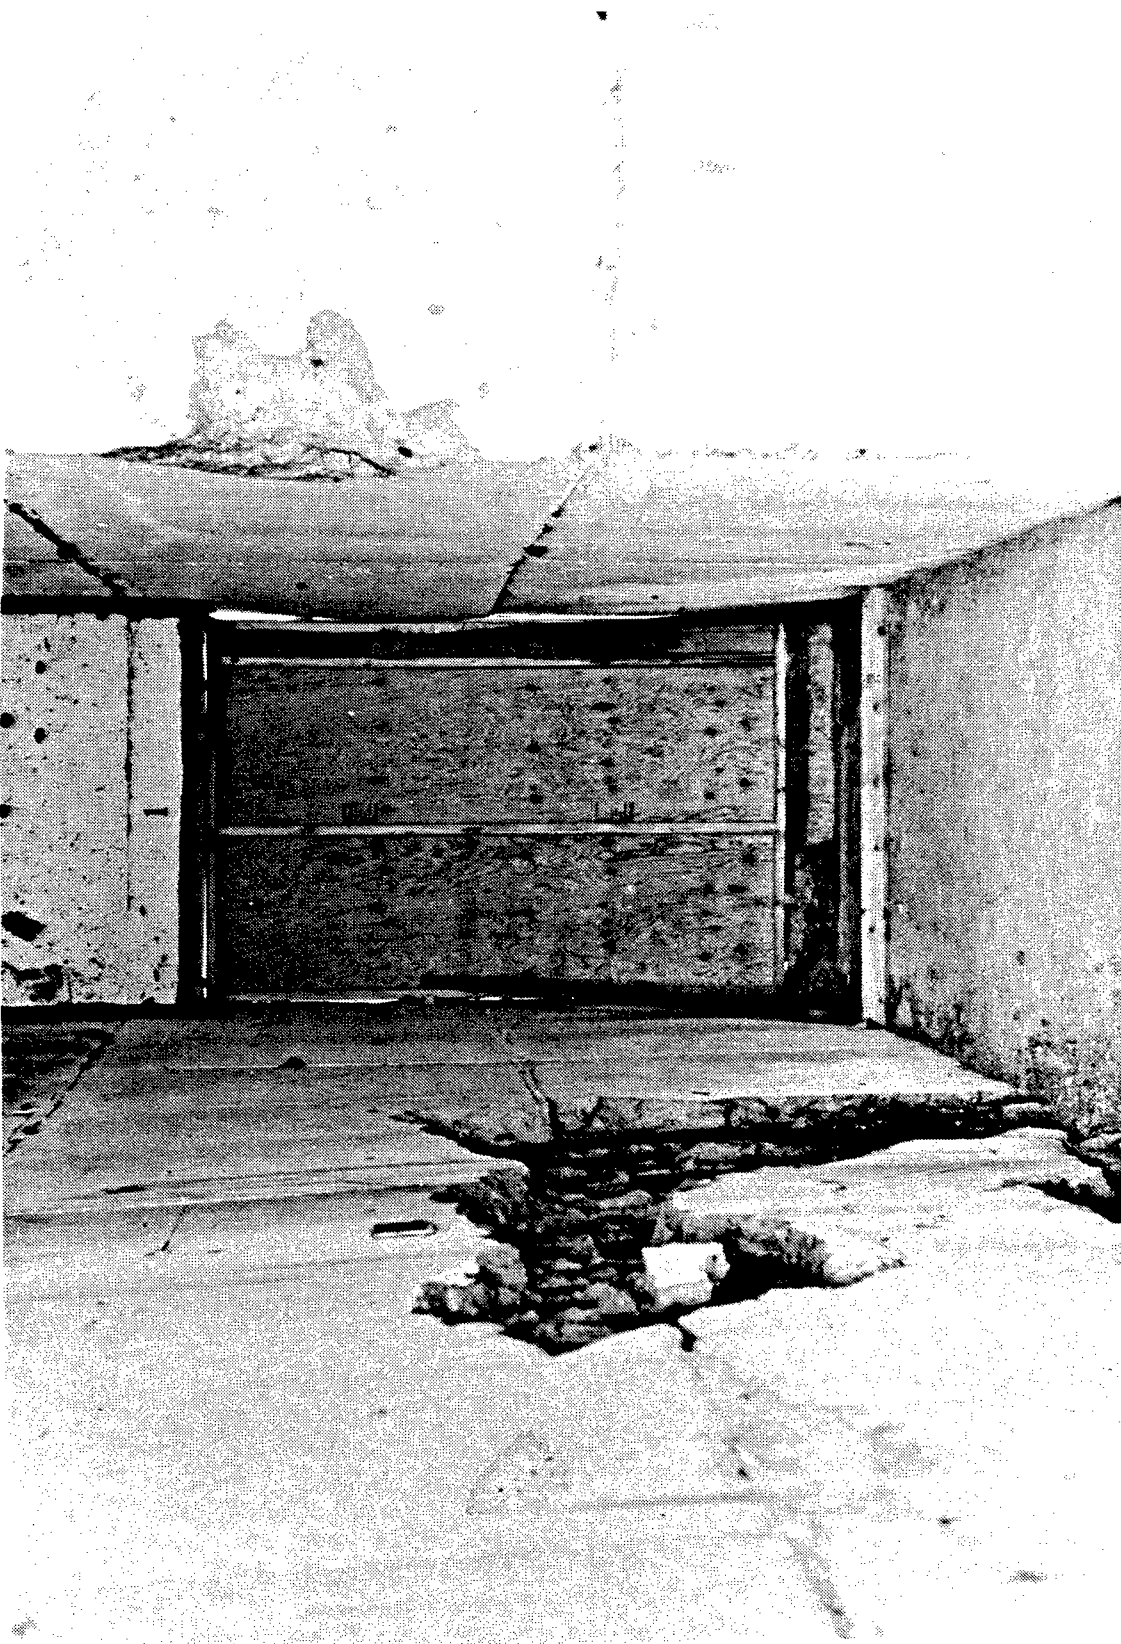
Figure 60. View 2 of Plywood Backing in the Door Opening.

To simulate a non-load-bearing wall replacement, a door opening in the NATO structure was used. This door opening, which is shown in Figure 57, is located in the eastern wall of the structure. Prior to the repair, Number 4 rebar stubs were welded along the top, bottom, and sides of the door frame at 1-foot intervals, as shown in Figure 58. The rebar was butt-welded and fillet-welded on both sides for 4 inches. The rebar stubs protruded 6 inches beyond the edge of the door frame. After placing the rebar, a plywood backing was installed in the door opening, as shown in Figures 59 and 60.

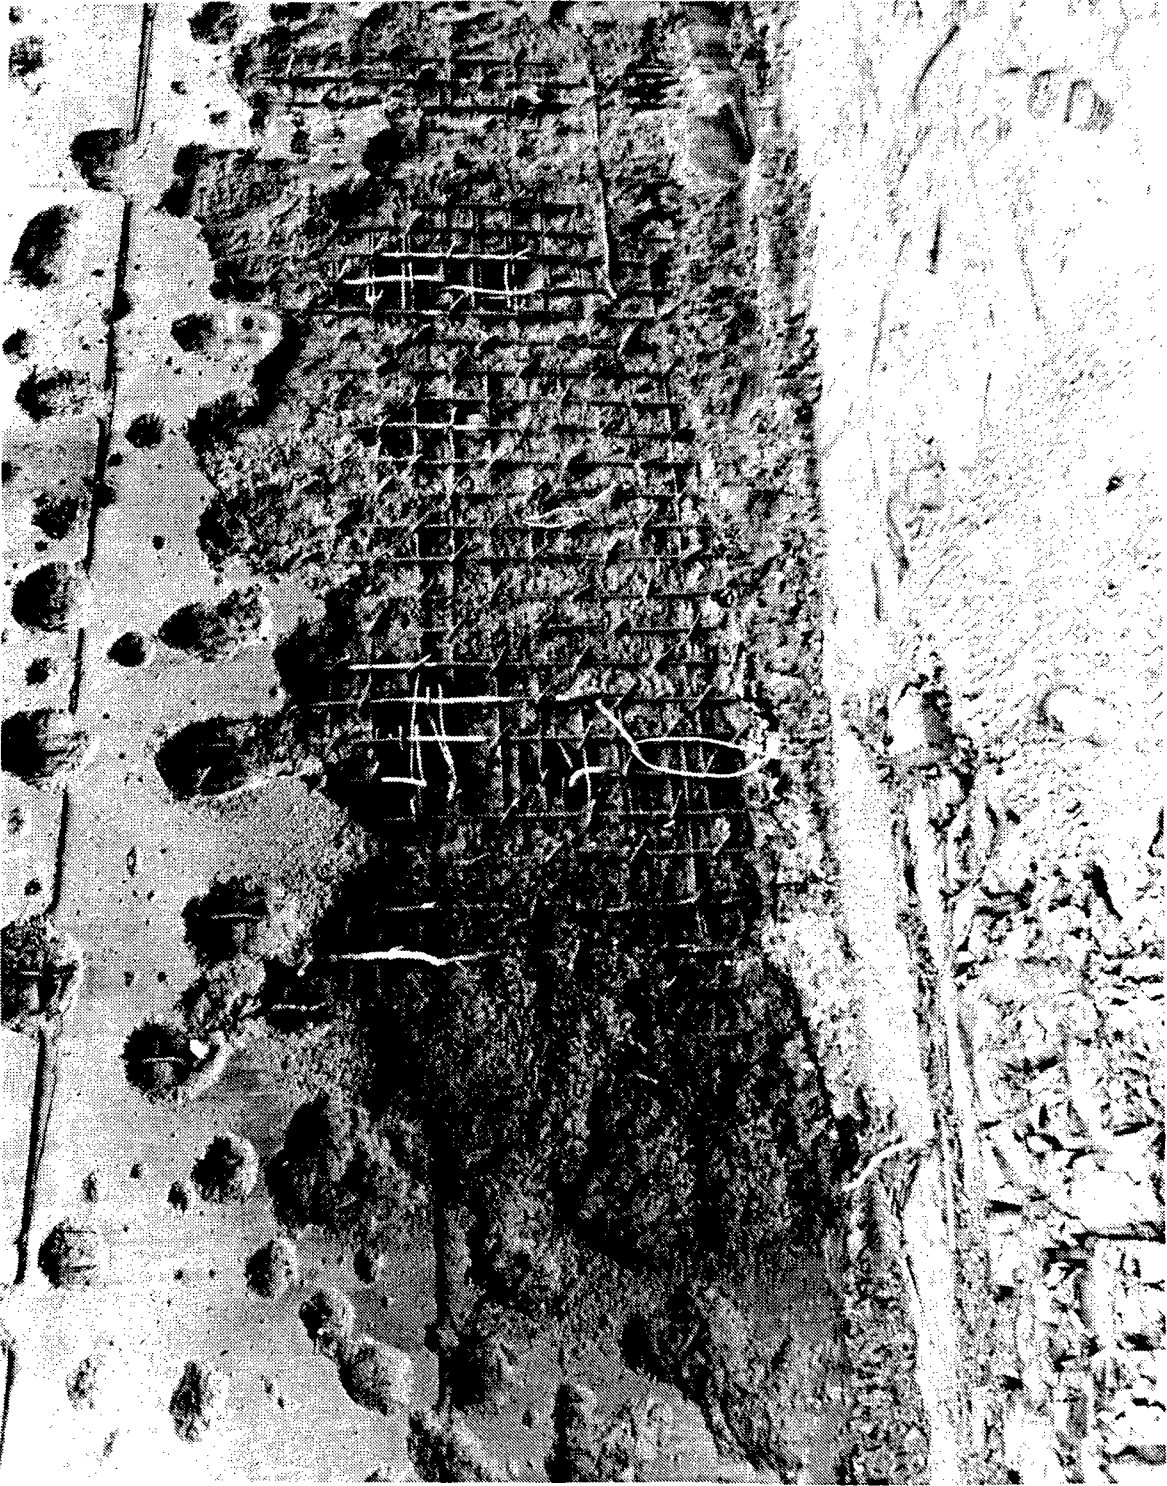
Figure 70. Completed Simulated Shotcrete Wall Breach Repair.

The repair area after shotcreting is shown in Figure 70, while the clogged feed cylinders of the shotcrete gun are shown in Figure 71. Upon investigation, it was determined that clogging of the cylinders was caused by having too large a surcharge of material in the gun hopper and wood feed funnel above the hopper. To alleviate this problem, the wood funnel was discarded, and only 3 or 4 inches of material was maintained in the hopper. Consequently, continuous monitoring of the shotcrete hopper was required, with frequent small feedings of material from the concrete bucket into the hopper. These new procedures were used during the wall replacement demonstration described below.

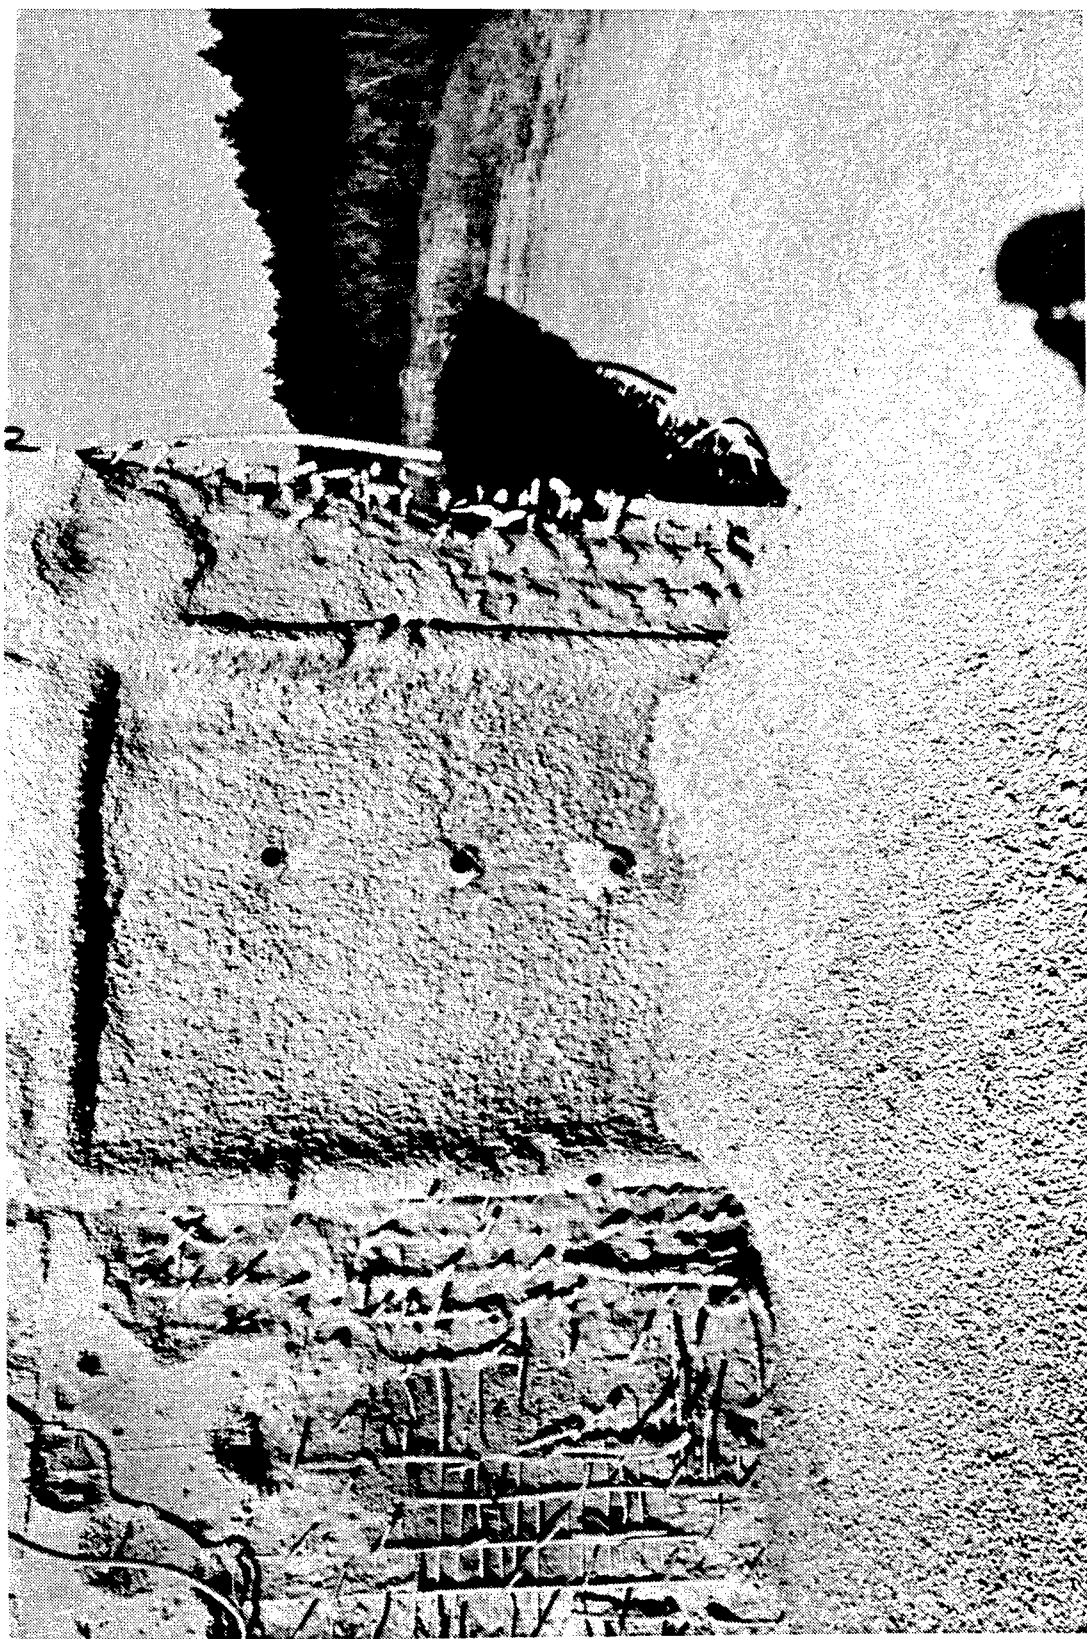
Figure 73. Completed Shotcrete Wall Replacement Repair.

Total shotcrete repair time on Day 2, excluding delays, was 34 minutes. The total time required to fill the concrete bucket twice, and position it over the shotcrete gun hopper was 65 minutes. Total demonstration time on Day 2 was 99 minutes. The completed wall replacement repair is shown in Figure 73. Due to shotcrete rebound, a large ramp of material was formed at the bottom of the repair, as shown in Figure 74.
